POTENTIAL-INDUCED DEGRADATION (PID) AT THE REAR SIDE OF BIFACIAL PERC SOLAR CELLS

K. Sporleder, V. Naumann, J. Bauer, S. Großer, S. Richter, A. Hähnel, M. Turek, C. Hagendorf

Fraunhofer Center for Silicon Photovoltaics CSP, Halle (Saale), Germany

6th bifiPV workshop

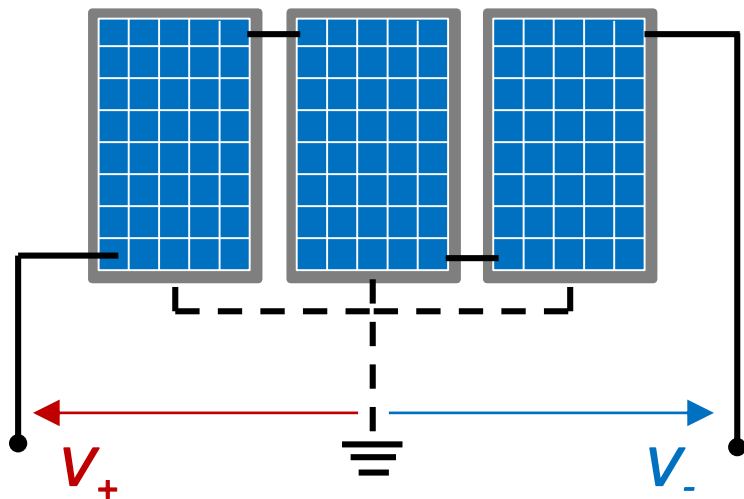
- Addition of serially connected module voltages
- Cause: high voltage between (grounded) module surface and solar cells
- Leakage current \vec{J} also at the rear side of modules

Series connection of PV modules with a floating potential

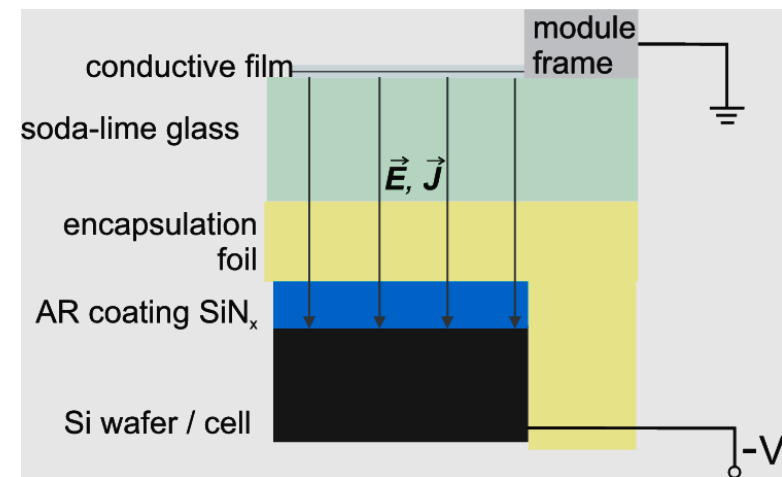
PV module under influence of high voltage

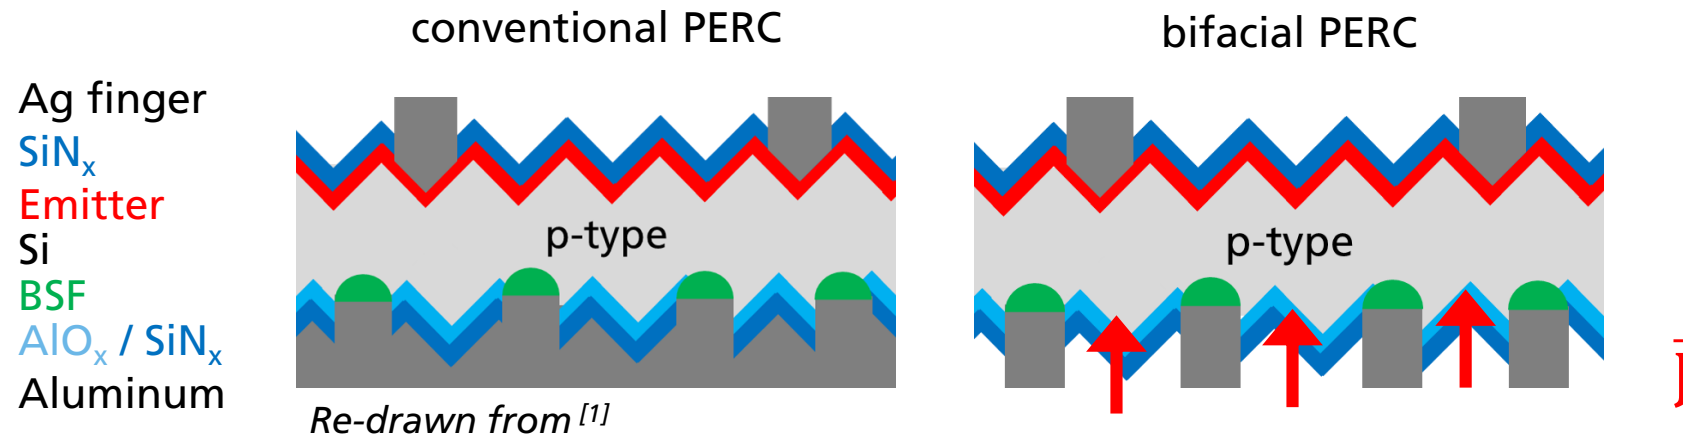
- Rear side power gain achieved by partial metallization at the rear side [1]
- Missing metallization: rear side is no longer shielded against electric fields [2]
- Additional path for **leakage currents at the rear side**

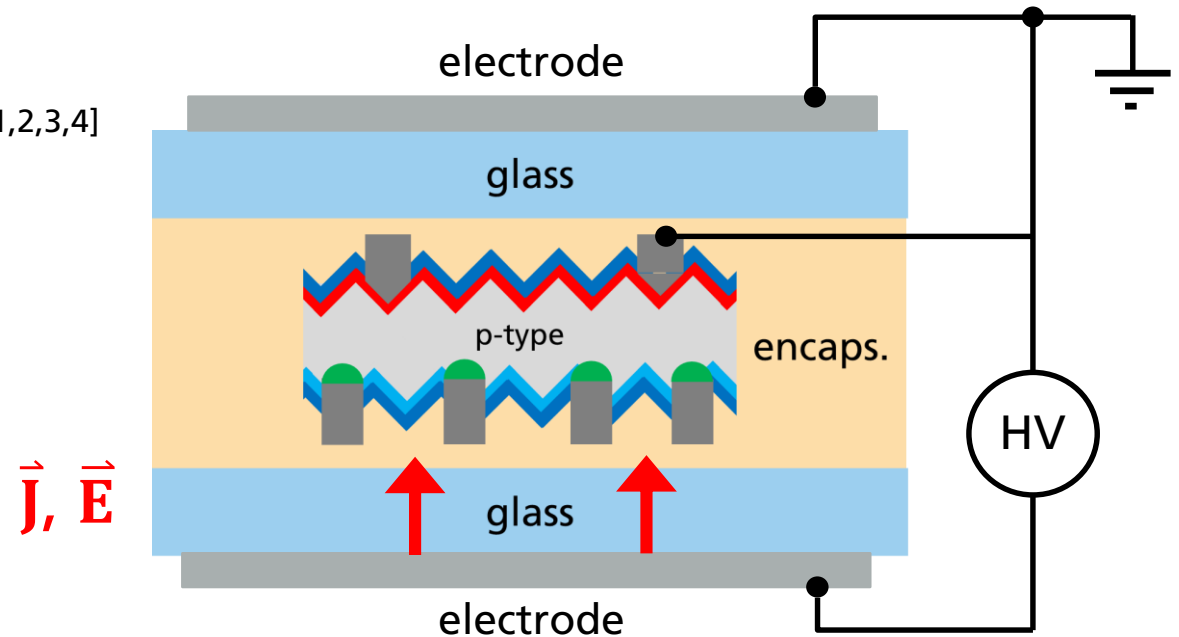
- Voltage $U = 1 \text{ kV}$
- High voltage is only applied to the rear side [1,2,3,4]

- Temperature:
40 °C [1], 50 °C [2], 60 °C / 85 °C [3,4]
- Duration: 24 h [2,3,4], 40 h [1]

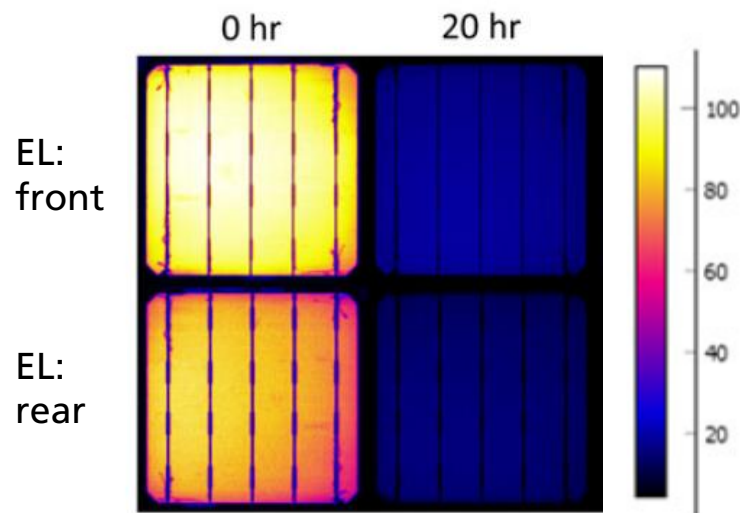
- Current and voltage loss
- No shunting of p-n junction
- FF is not the dominating loss factor
- Full recovery achieved after illumination (unlike PID of the shunting type, PID-s)

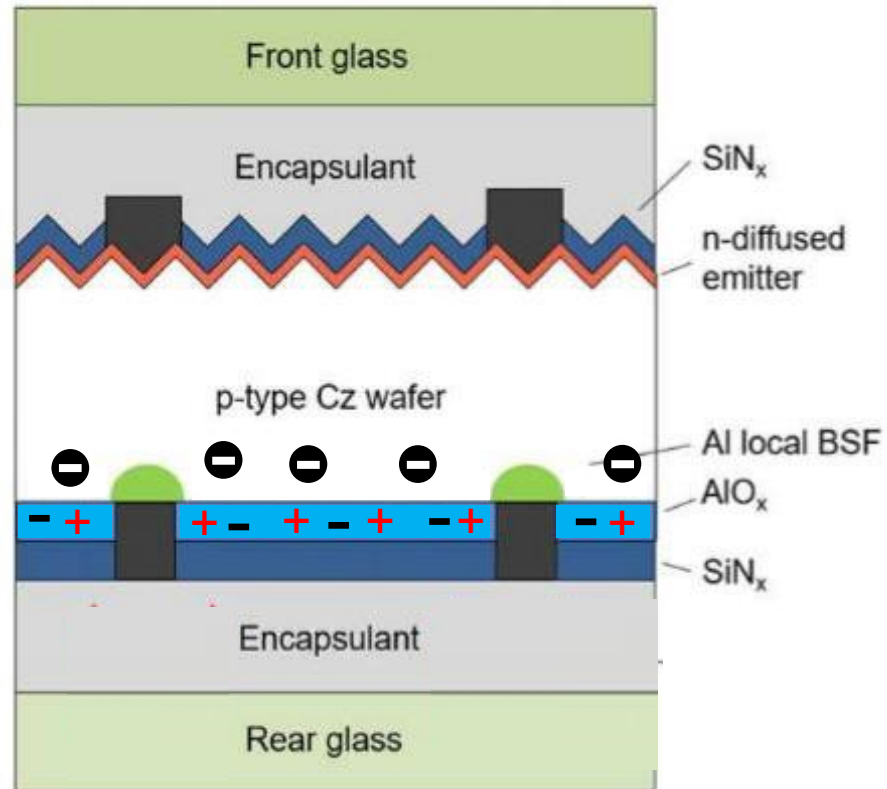
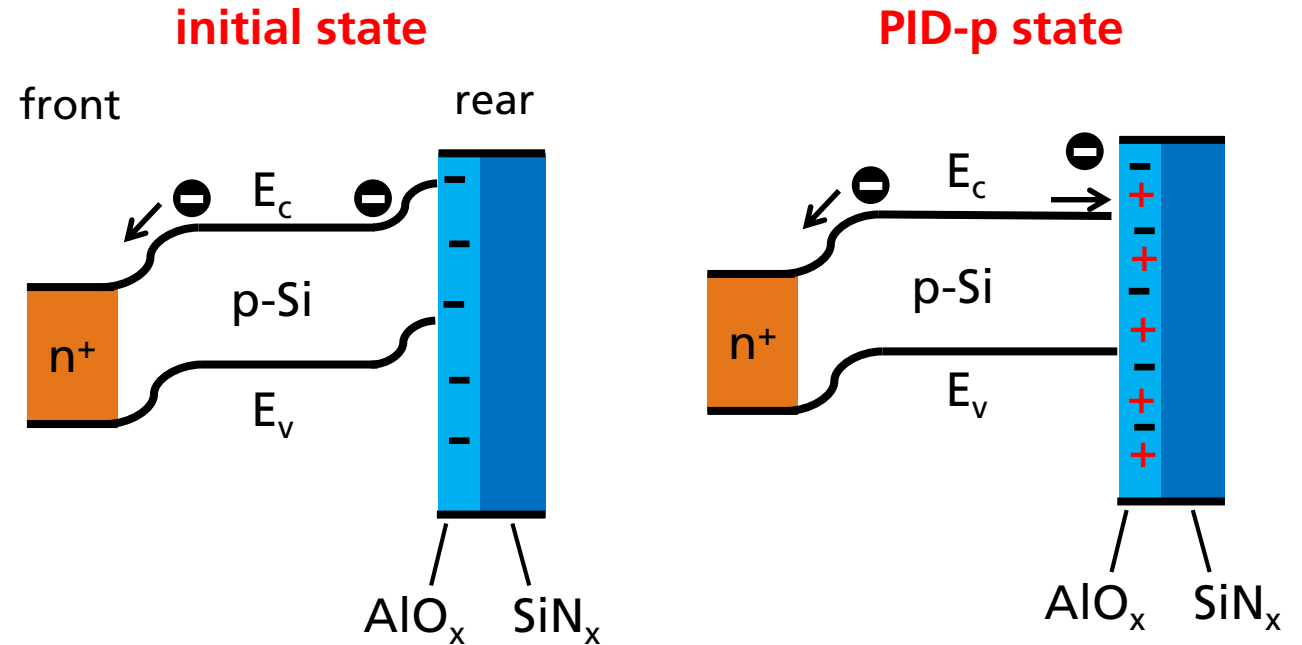
De-polarization of charges in AlO_x passivation layer (PID-p)

- De-polarization ~ compensation of field effect passivation [1,2]

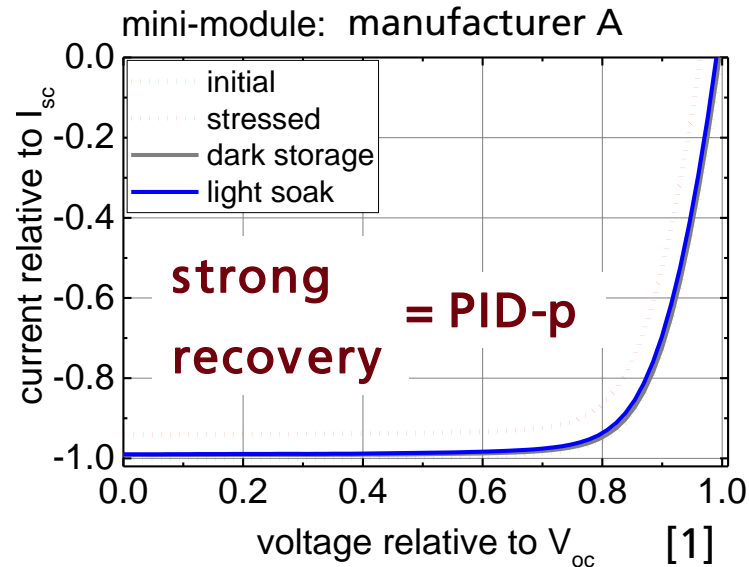
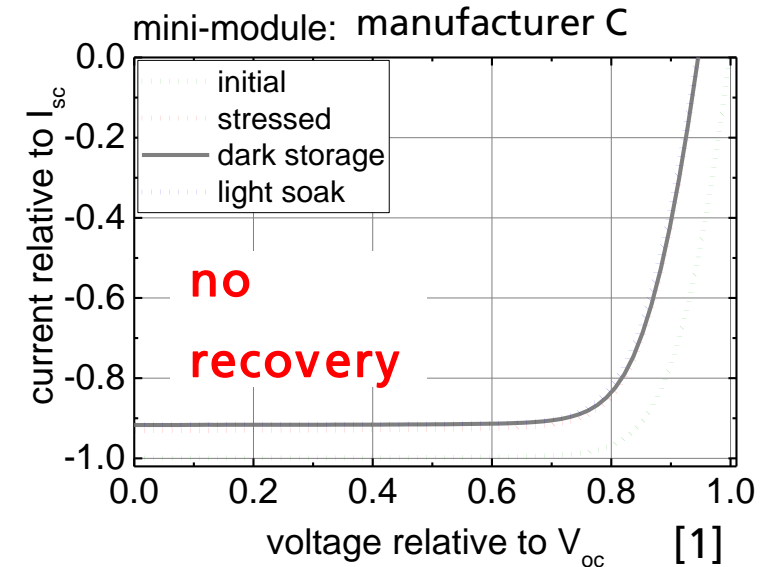
- PID test 60°C, 1000 V, 24 h
- Dark storage: 220 days
- Light soak: 4 h @ 1000 W/m²
- All cells are
 - p-type mono
 - bifacial PERC
 - but from different manufacturers

Power losses (relative to initial state)

A	C
PID test	-9.7%	-12.7%
dark storage	-0.8%	-13.9%
light soak	-2.1%	-14.7%

- New PID-type → not PID-p
- Different PID behavior for the same cell type
- Manufacturers need to know the critical process steps

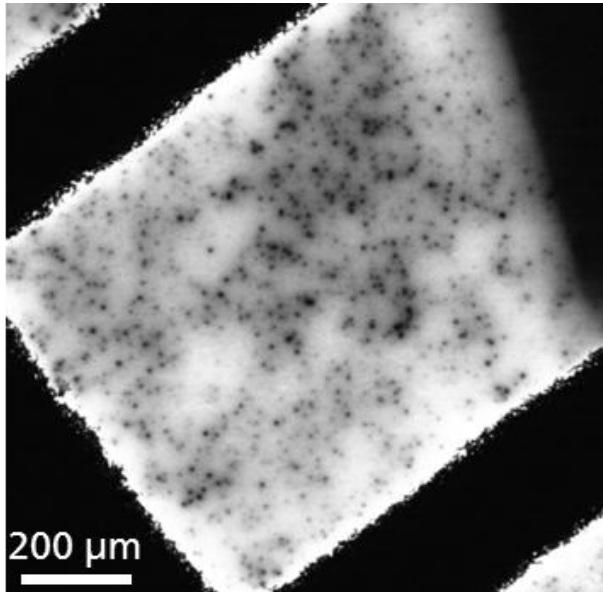
LBIC, 555 nm ^[1]

- Lateral inhomogeneous recombination at PID sample after PID test (85°C, 1000 V, 24 h)
- Topography: circle shaped damages of passivation layer → holes → “PID of the corrosion type (PID-c)”
- EBIC reveals independent sub-surface defects → stacking-fault (SF)

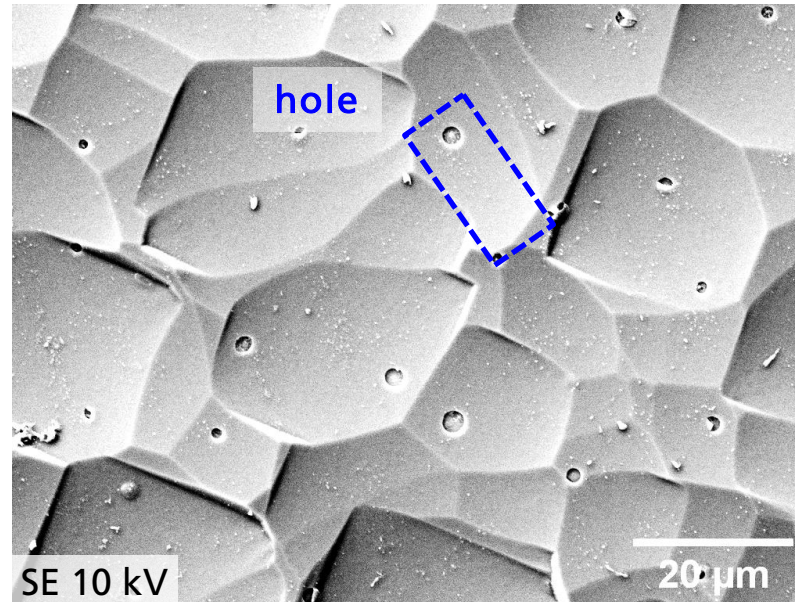
SE 10 kV
SEM at rear surface: topography ^[2]

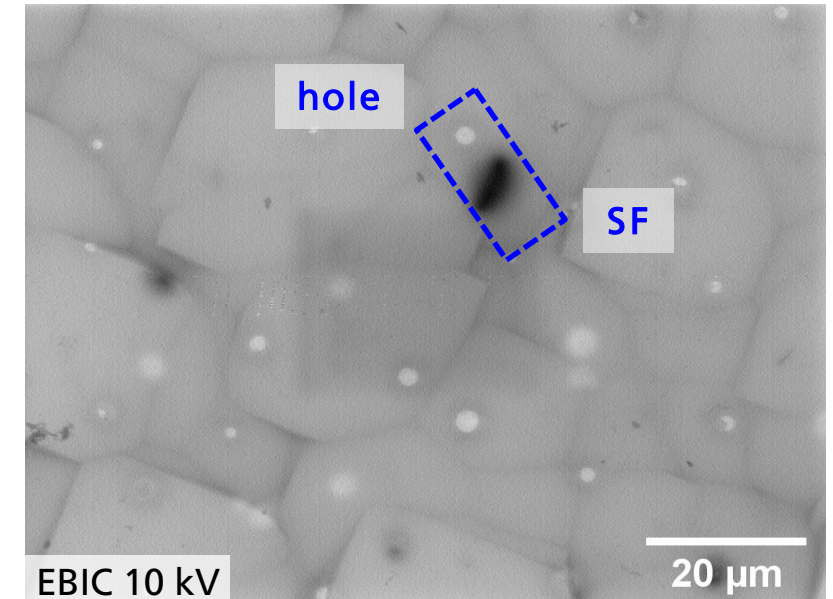
EBIC 10 kV
Electron Beam Induced Current measurement ^[2]

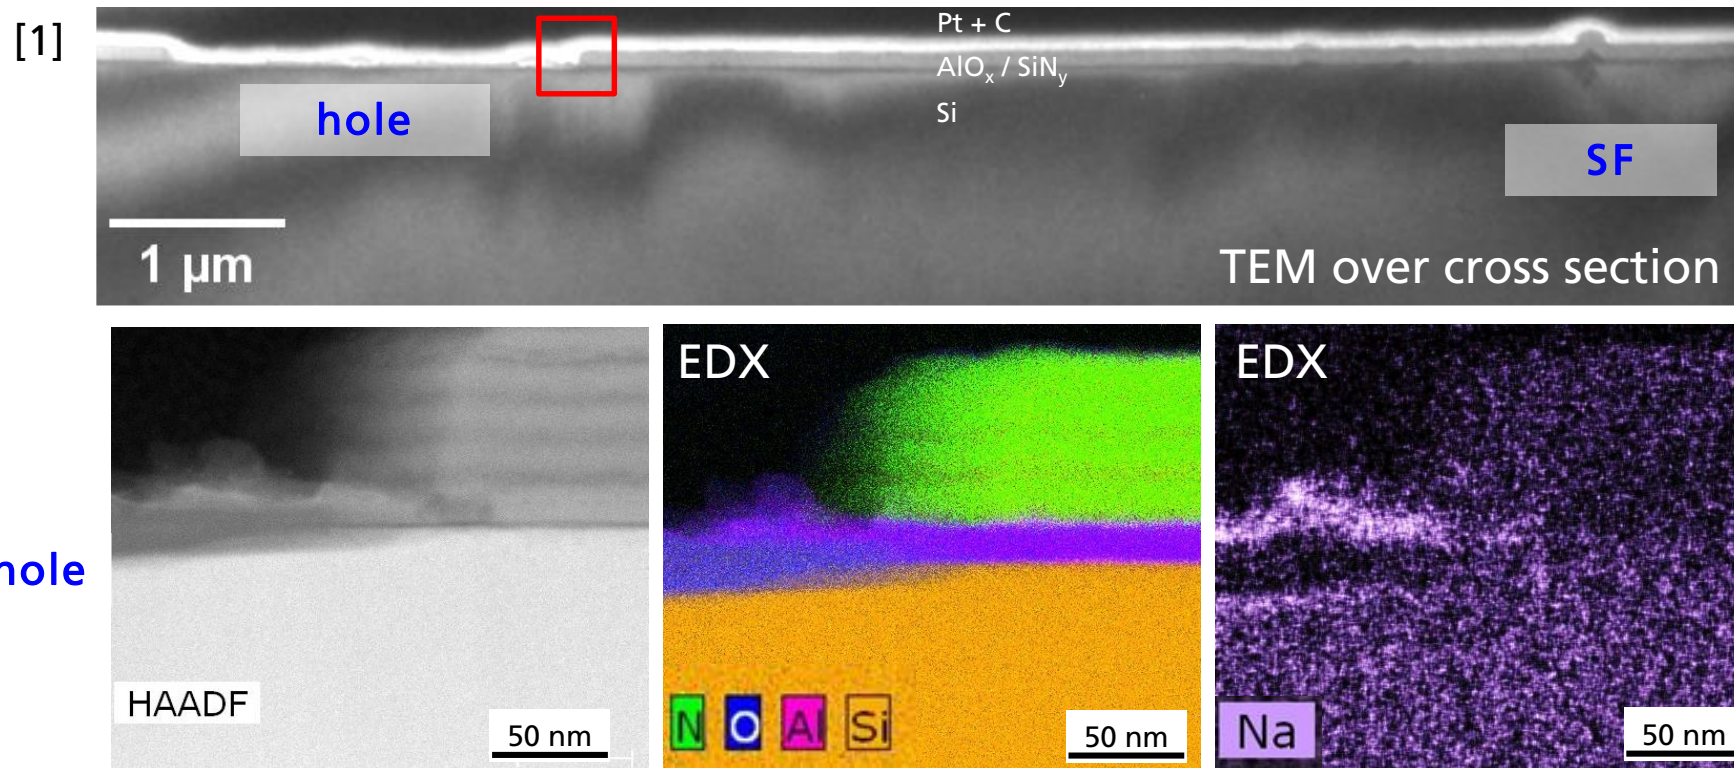
Hole-like defects due to a corrosive PID type (PID-c)

- Local SiO₂ formation at Si / AlO_x interface (30 nm thickness, no native oxide)
- Alkali metal impurities found (Na, K, Ca)

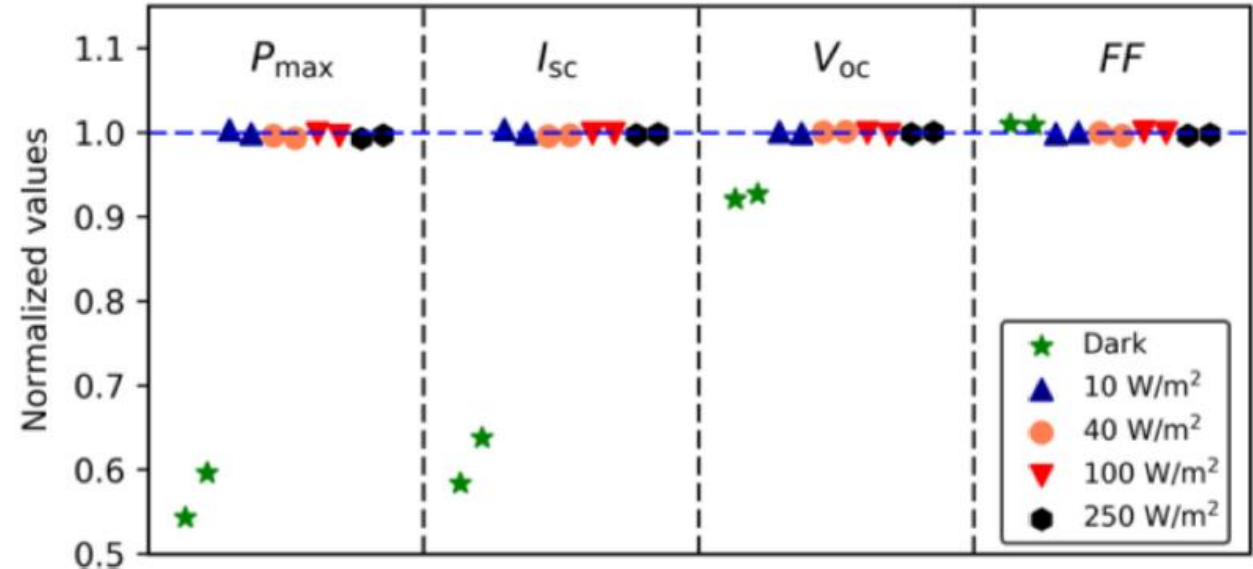
- W. Luo et al. [1] show that illumination can prevent PID on bifacial p-type PERC cells
- 10 W/m² are sufficient to suppress PID

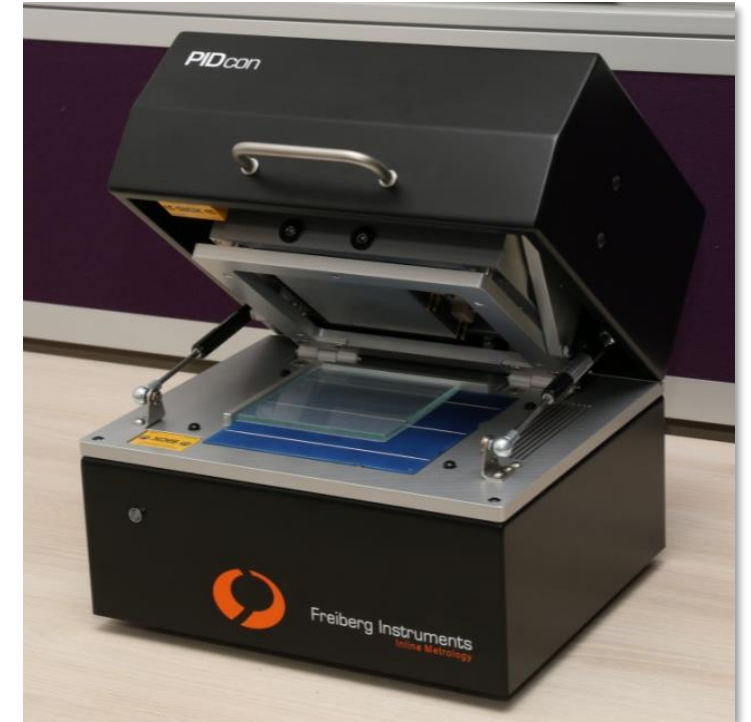
PIDcon (Freiberg Instruments)

- PID cell tester 'PIDcon' adopted for bifacial PID testing
- Discrimination between PID-p and PID-c
- Later version with simultaneous illumination
